# Manhole Inspection Summary

Manhole # S17AA2015MH

**Location** Address: **2015 ROGERS AVE**

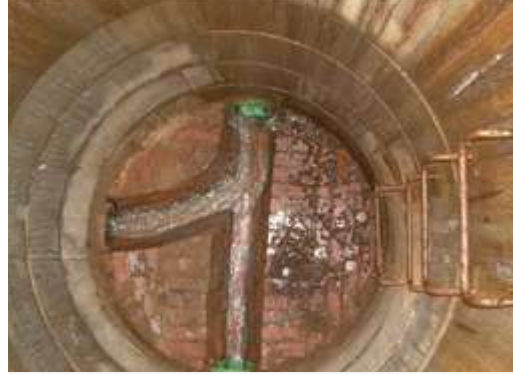
Top View

Barrel infiltration. Bench debris.

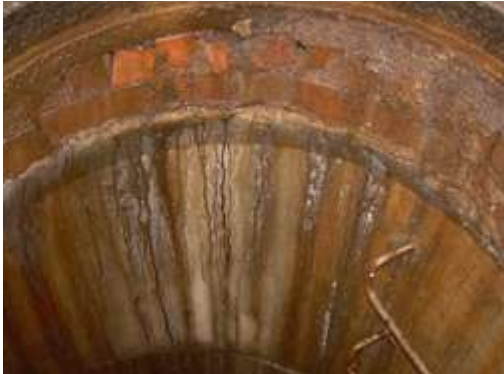
Defect

Frame leaks. Adjustment deterioration and infiltration. Corbel infiltration.

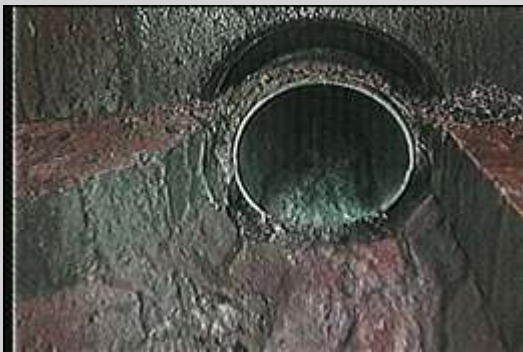
### 8 in. Circular Gravity Sewer Pipe Out @ 12 O'Clock

Infiltration: **Evidence** Pipe Seal Cond: **Unknown**

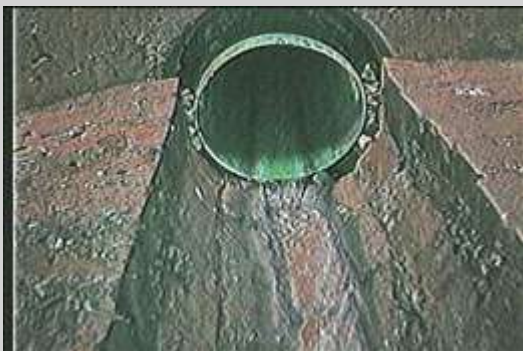
### 8 in. Circular Gravity Sewer Pipe In @ 6 O'Clock

Channel deterioration.

Infiltration: **Evidence** Pipe Seal Cond: **Unknown**

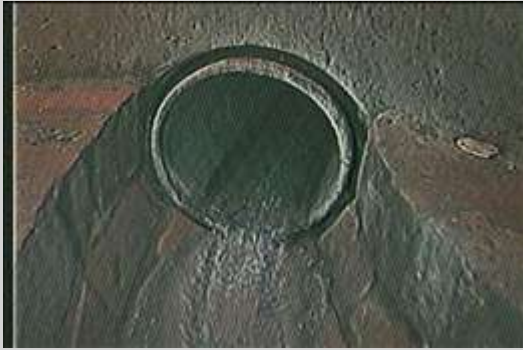
Pipe In @ 9 O'Clock

Infiltration: **Evidence**
